1 1 Other cases of food ultrasound test case application of ultrasonic non-destructive inspection equipment for industrial use, and tuna

Case of ultrasonic nondestructive testing equipment EPOCH1000i application experiment

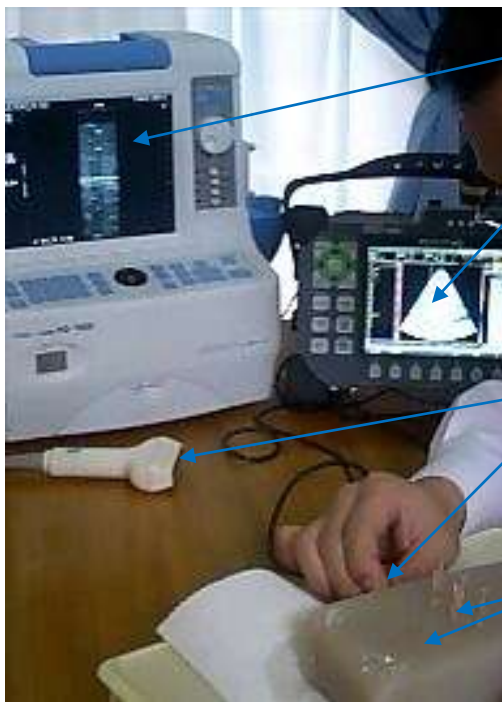
The following photo has been conducted to adjust the application experiment HS-1500 is left of the screen medical ultrasound equipment, industrial equipment without the right acoustic lens, is the situation under in preparation for observing the tuna now to 5MHz phased array method of Epoch1000i manufactured by Olympus

Gray scale image display HS-1500 medical ultrasound equipment

Ultrasonic non-destructive inspection equipment for industrial use Epoch1000i Switching system displays two color scale, gray scale Epoch1000i probe is small, its size is about 15 mm diameter shaped dice of one side

Photo is a device for industrial ultrasonic nondestructive testing of Epoch1000i manufactured by Olympus. Feature is the product of two-dimensional visual assessment is possible by scanning sector of the Phased Array type. Development has been used in order to be commercialized for the purpose of detecting the damage microstructure of metal, metal to detect corruption of the aircraft as practical examples.

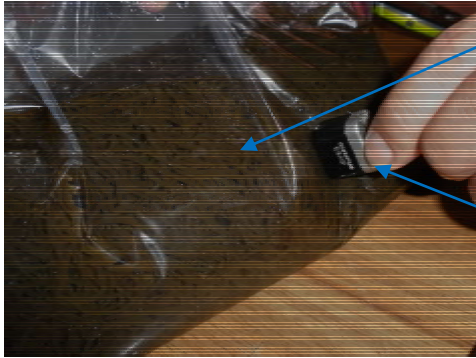
Mozuku ripe specimens from Okinawa

Single ultrasonic transducer

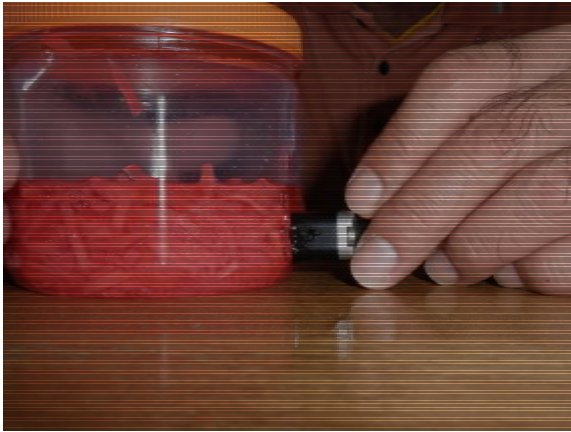
Red ginger samples

Single ultrasonic transducer

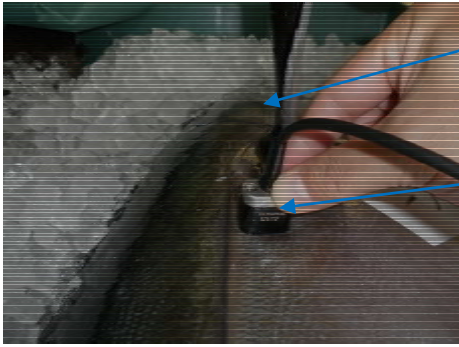
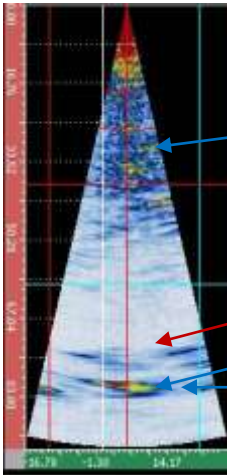
Bigeye specimen

Single ultrasonic transducer

Chiai muscle

Wrap multiple reflection artifacts

Freshness is higher by observing the maintenance of muscle Chiai

Vertebra

Because there is no body burnt spine reflected signal

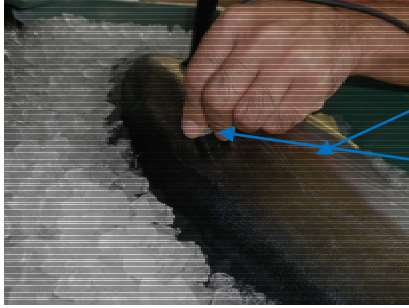
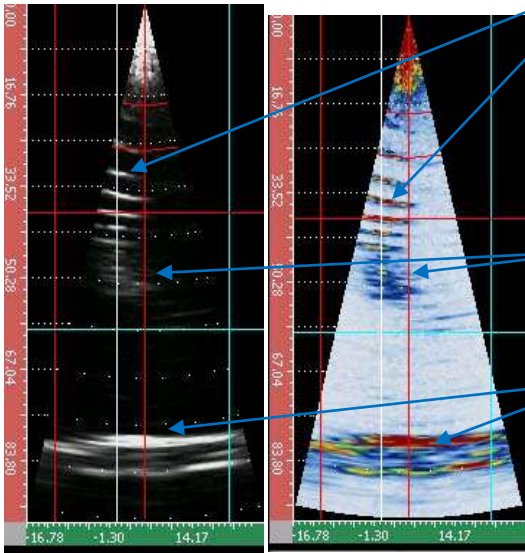
Bigeye specimen

Single ultrasonic transducer

Muscle and sarcomere spacing has been observed clearly

Chiai muscle

Vertebra

Because there is no body burnt spine reflected signal

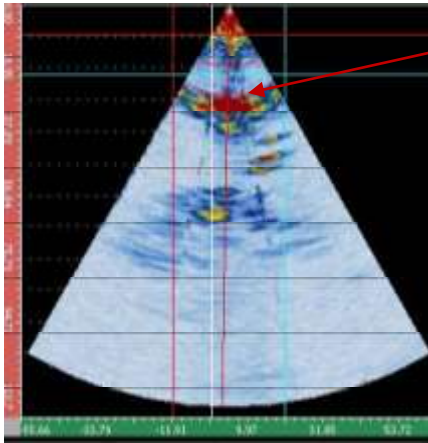
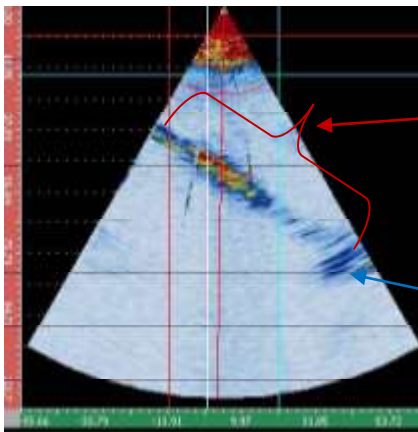
Abnormal quality

Abnormally ultrasonic signal region

Area vertebra signal

Recognize the abnormal signal of the strip toward the vertebral

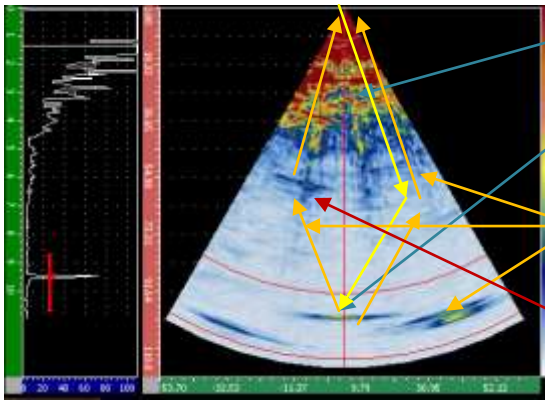
Shows an image of canned mandarin orange. This is the initial testing was done in by OLIMPUS Have depicted the presence of a weak mandarin orange that has passed through the very boundary of the acoustic impedance difference. Multiple reflection artifacts can occur in the internal surface is relatively minor, or due to the shape of the cans, the filter function of the device Why there has been no elucidation.

Recognize the echo reflection indicates the presence of a mandarin orange Bottom reflection echo signal strength to admit the beam orthogonal unit Have caused the displacement of the bottom echo, false images by internal reflection canned False images caused by multiple reflections

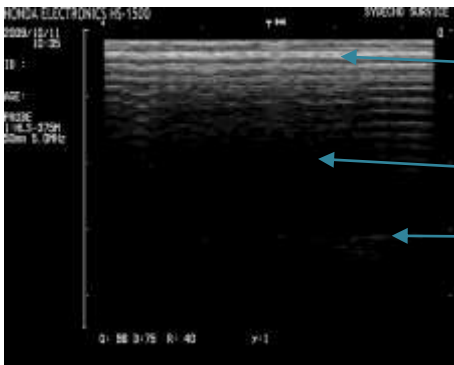
5MHz ultrasound image of an aluminum pack meat sauce HS-1500 in a manner similar equipment Recognize the reflected signal of the opposite side surface of an aluminum pack, inside the lesion characteristics, the observation of internal fluidity of the material was able to test at dynamic.

Multiple reflection noise is strong  
 No loss of echo signal  
 Admit slightly backwall echo

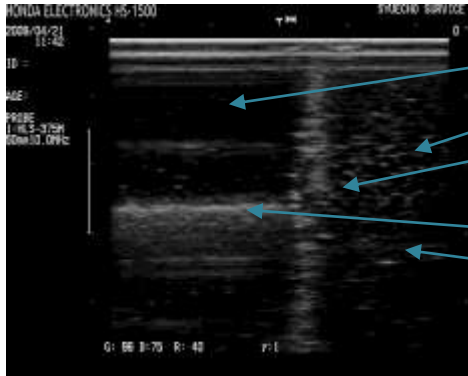
Image boundary surface put salad oil and water in plastic bottles

Clear, echo-free area of the water Gee nick echo area of the oil Boundary surface are shown in the left slope observed zonal high brightness, a cross-sectional findings 裂様. Wrap the bottom echo image bottled water Wrap oil bottle bottom echo image

(Transparency) is understood velocities and attenuation constant of water  
Image plane of the boundary surface of the central

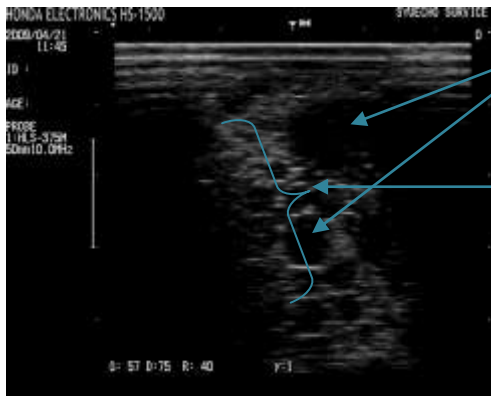
Acknowledge the change in internal anechoic oval. Suggest that the water and sink to the oil bubble on the nature of ultrasonic Seen floating in the water fine structure echo Geonich. Suggest that the bubble of oil floating on water.

Determine the shape of the bubble with water at

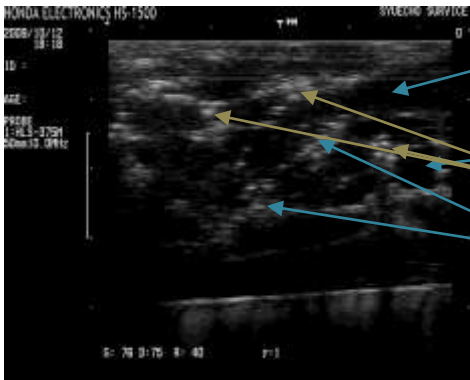
10MHz ultrasound photo photo salted salted squid vinyl pack Pickled sauce is only echo geonich, the squid is the amount per body weight seen by the positive uniform hypoechoic area calculation.

Ultrasonic probe  
A strip of squid  
Pickled sauce

Long axis of the strip squid, uniform low-echo  
Short axis view of the strip squid, uniform low-echo  
Small bubble of air admit  
Pickled sauce, coarse non-uniform high brightness

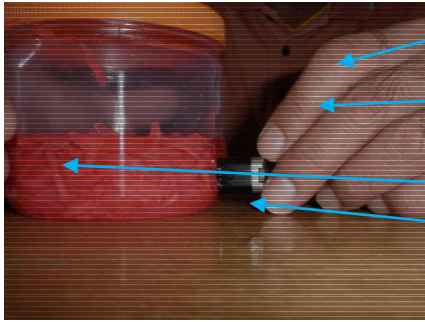
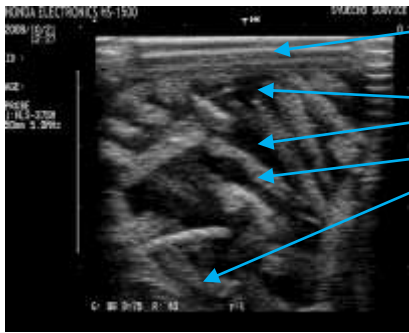
Plastic containers  
 Pickled sauce  
 Ultrasonic probe  
 Red ginger  
 Multiple reflection artifacts due to poor  
 adhesion probe A clear echo-free pickled  
 sauce Has become possible to observe  
 internal transparency and good ginger  
 with poor ultrasonic transmission is  
 fully exploited, which is negligible  
 attenuation Can be determined that  
 ginger was exploited

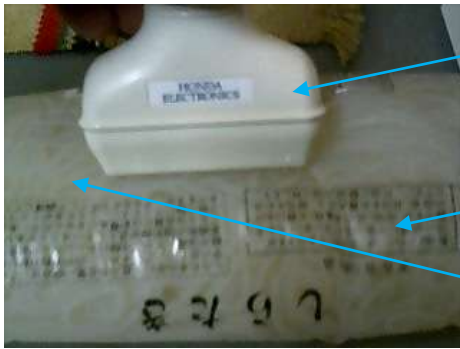
## Noodles made from konnyaku

Ultrasonic probe

Internal plastic pack is filled with pickled sauce Shirataki-shaped Somen has been tightly sealed in

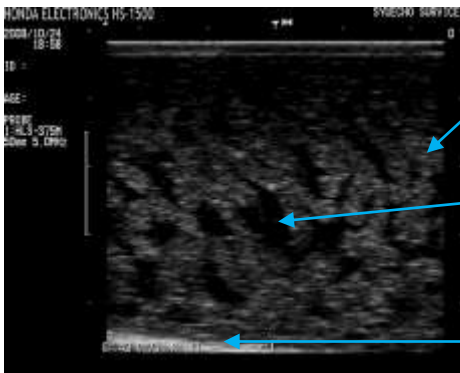
## しらたきの超音波像

Be observed elongated been chained rosary is like fine granules shows a relatively low uniform echo reflection of Shirataki Pickled sauce is a clear echo-free

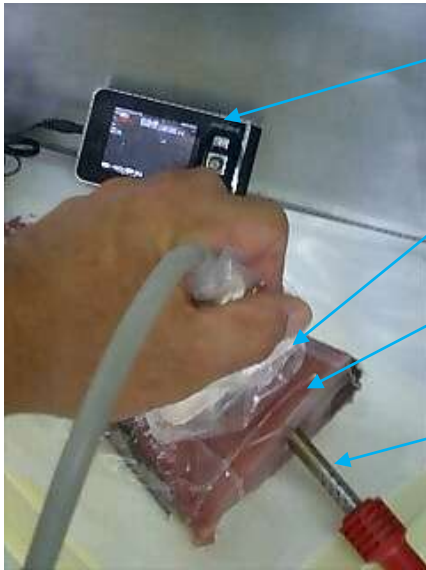
Experiment burnt tuna

- HDD built-in color monitor
- Ultrasonic probe
- Simo block back in the yellowfin tuna
- Toro Plug in the soldering iron heating

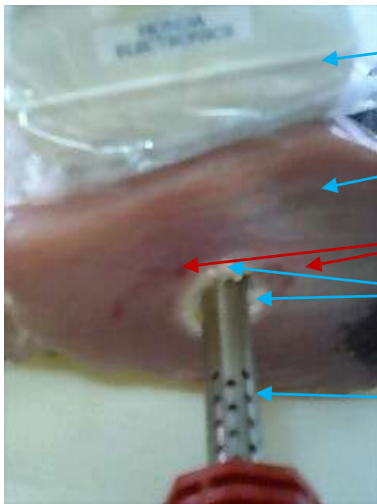
- Ultrasonic probe
- Simo block back in the yellowfin tuna
- Toro
- Bleeding of blood
- Progress in the heat of the soldering iron
- burn Soldering iron

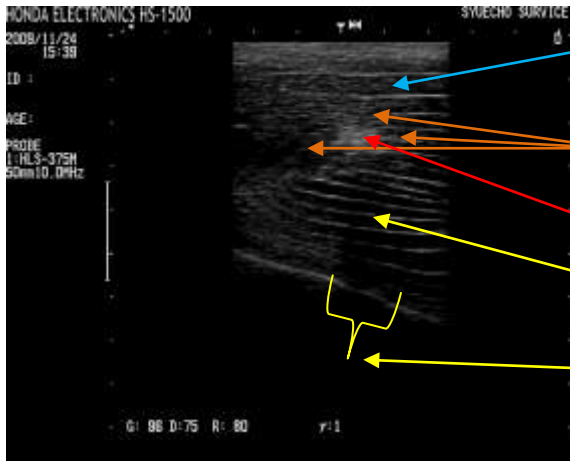
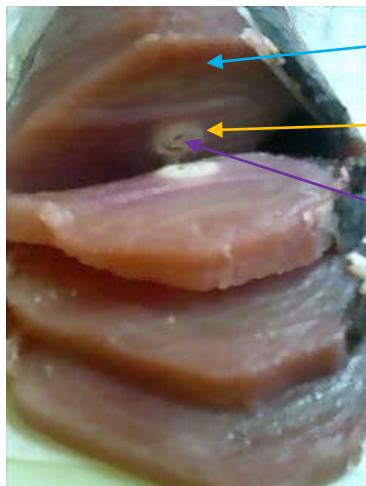
Distinct muscle fiber  
 Changes in the muscle fibers begin to be seen Obviously rough hyperechoic Degree of muscle obfuscated  
 Tic appearance of acoustic shadow

There is no significant change in particular  
 Obvious burnt Finds traces of soldering iron insert in the center

Burnt part will change roughly hyperechoic on ultrasound observation by experiment, can be seen the emergence of (shadow) according to the degree that the loss of backward echo Contraction biceps muscle of the upper arm extension ultrasound image (large biceps) Contraction are shown to promote uniformity and transparency becomes dense hypoechoic muscle cells Be observed in non-uniform rough hyperechoic when compared to muscle cell contraction stretching becomes sparse Of addition and subtraction can be determined and its expansion and contraction of the muscle area and observe real-time while performing bending and stretching exercises. In the case of internal bleeding were often seen the advent of echo-free space In addition, many may be observed in this way also the case of congestion.
